#### **(4) Camp Creek Log Weir Removal And Large Wood Placement Project (2011-2014)**

Malheur National Forest, Blue Mountain Ranger District, Bob Hassmiller, Zone Hydrologist.  
Case study prepared by Dan Armichardy, United States Forest Service

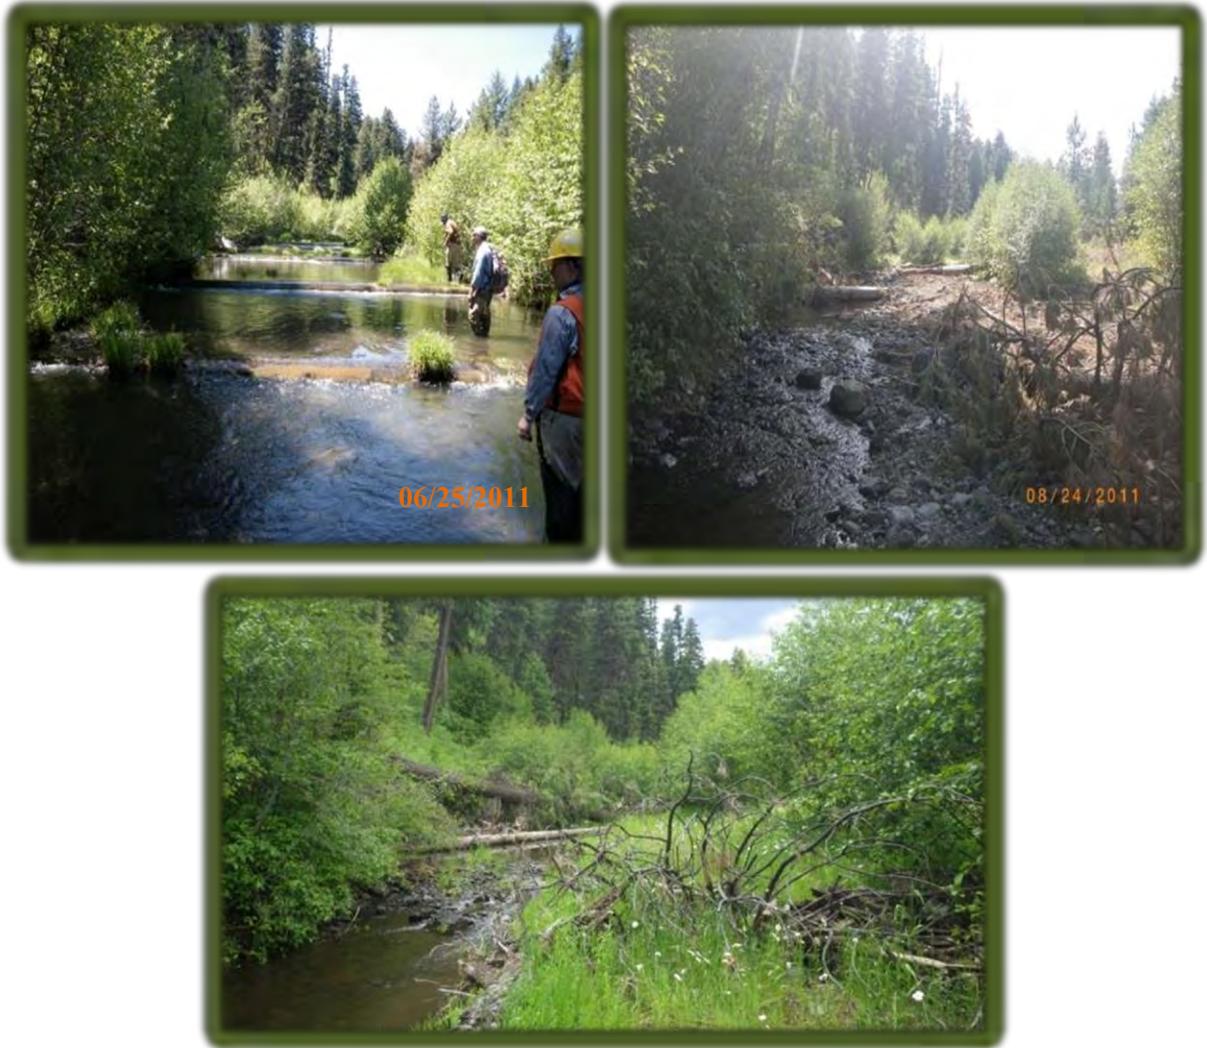
**Figure 47:** Log Weir Removal from Reach 4 of Camp Creek before (top left), immediately after (top right), and 3 years later (bottom)

One of the primary goals identified within the Camp Creek WRAP included the removal of approximately 238 log weirs within Camp Creek watershed. Large wood structures and trees with rootwads were placed in Camp Creek within the same vicinity of log weir removal in 2011 (see Figure 47). 123 log weirs were removed or modified during this work in the lower sections of Camp Creek.

Stream channels within the reaches where log weirs were located have narrowed and vegetation has colonized exposed stream banks. The majority of pools created through excavation have been maintained by instream wood. Gravel sorting is evident throughout the reaches that were predominantly plane bed with an armor layer of cobble that functioned as a transport reach (slope 0.017). Based on this evidence the project continues to improve Mid-Columbia River Steelhead habitat deficiencies identified within the Camp Creek WRAP.

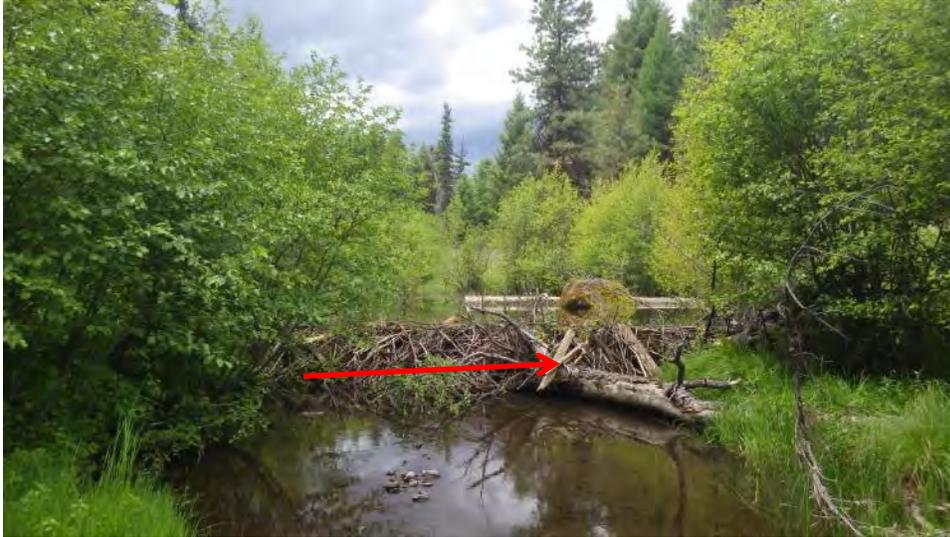
**Figure 48:** Medium size (< 12 inch) diameter ponderosa pine placed in mid-channel in 2011 following log weir removal. Beaver dam has incorporated rootwad into center of dam (6/15/2014).

In 2014, beaver moved into a portion of Camp Creek where log weirs were removed, pools were excavated, and wood was added (see Figures 51 and 52). While historical beaver evidence was present within Camp Creek, transient beaver activity and dams have been noted but no prior large dams, such as those observed in 2014, were documented within lower Camp Creek. Many of the dams that appeared in 2014 were keyed into placed wood or boulders for added stability and persistence (Figures 48-50). Additionally the beaver dams backwatered the placed wood structures and the excavated pools increased the depth upstream of the dam to over 5 feet in places. Observations indicate beaver are using the wood structure locations as dens and the deep excavated pools as food caches for over wintering. During the spring of 2015, several smaller dams were breached leaving large gravel patches (built by beaver for dam construction). Several steelhead were observed constructing redds in these breached areas. This provides an example of combined salmon/beaver because the same limiting factors affecting salmonids may also be limiting beaver – the two are not exclusive, but share a common beneficiary relationship. Dams anchored to large wood tended to be taller, had more internal stability and had a larger hydrologic zone of influence (see Figures 48 and 50).

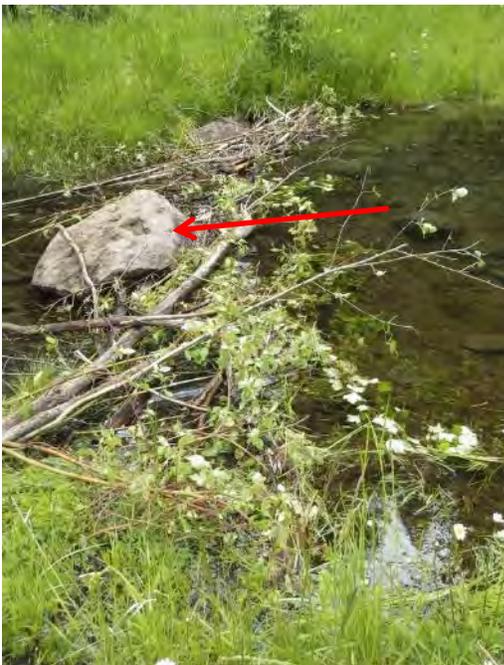
**Figure 49:** Existing rock placed mid-channel during log weir removal 2011 has been incorporated into beaver dam (6/15/2014)

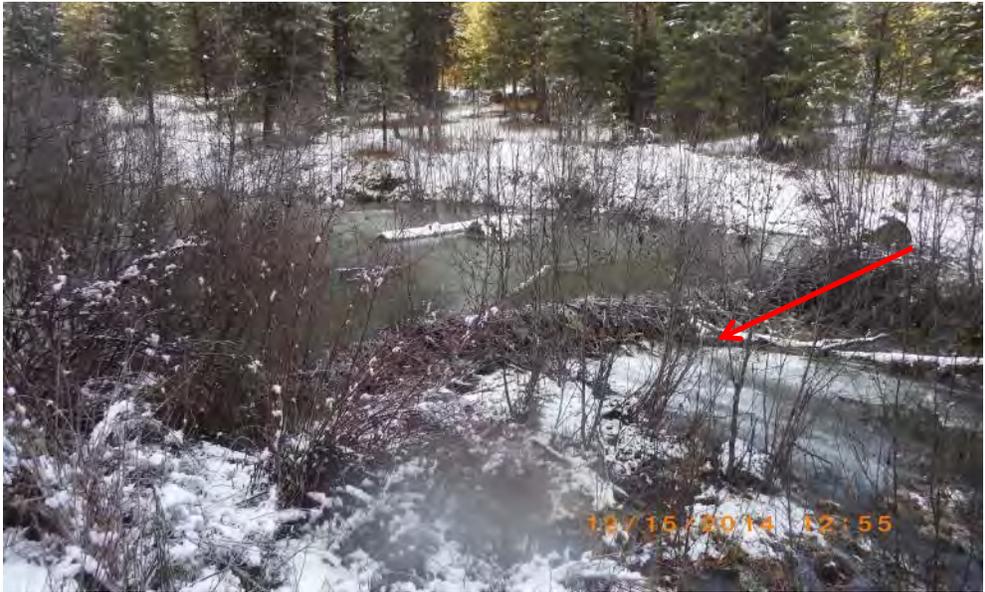
**Figure 50:** Beaver dam with rootwad incorporated (12/15/14)

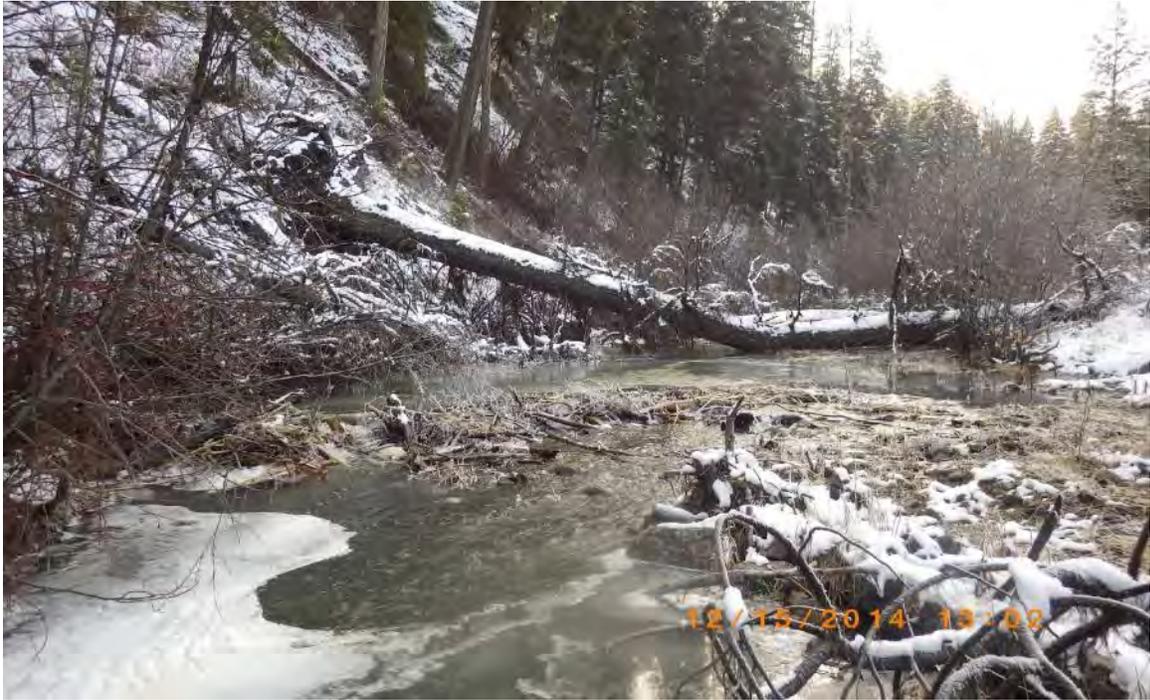
**Figure 51:** Smaller beaver dam built at pool tail out without wood (12/15/14).

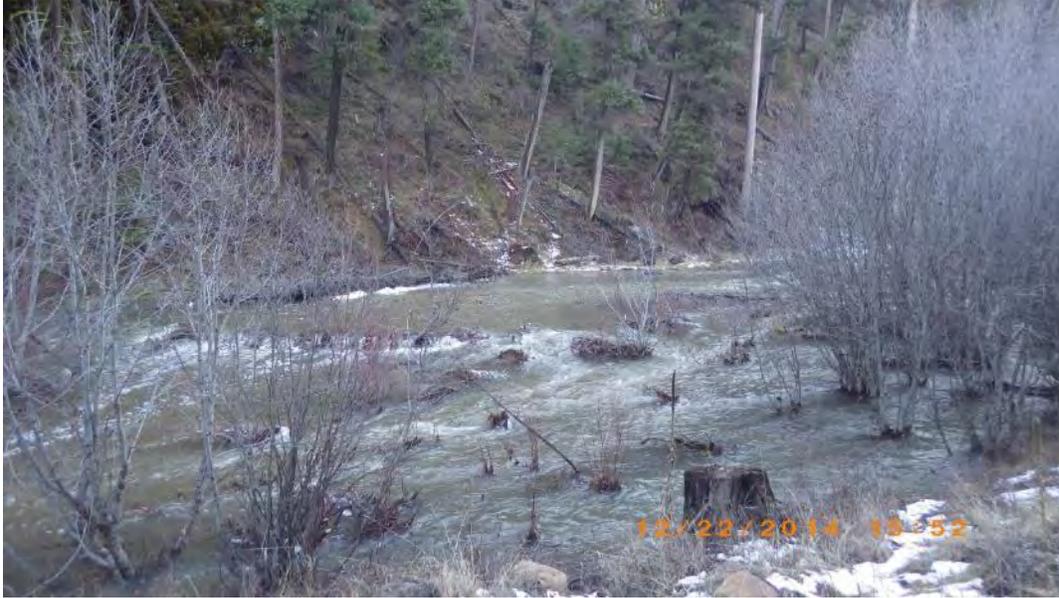
**Figure 52.** Valley bottom being inundated with moderate flood because of beaver dam influence (12/22/14). Same dam as Figure 52.
